Manhole Inspection Summary

Manhole # S29G__005MH

Insp Date: **1/26/09 9:11 AM**

Location Address: **730B W Fayette St**

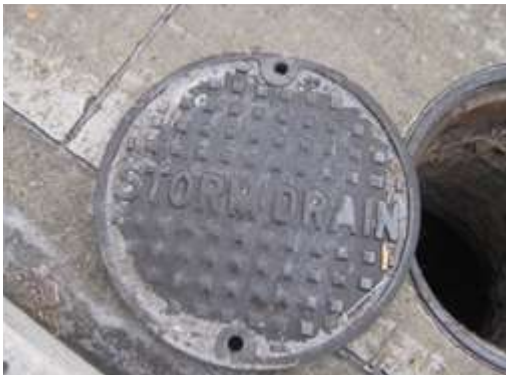
cover pic

has storm drain cover

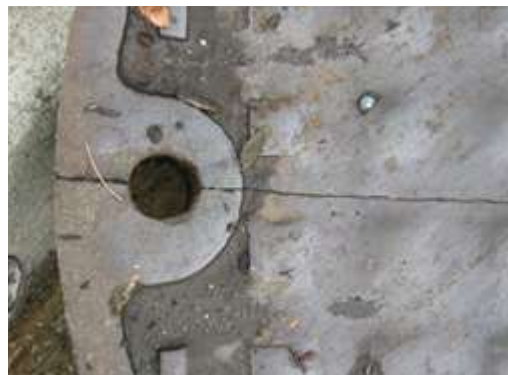
Defect 2

Condition: **Cracked**

cracked lid

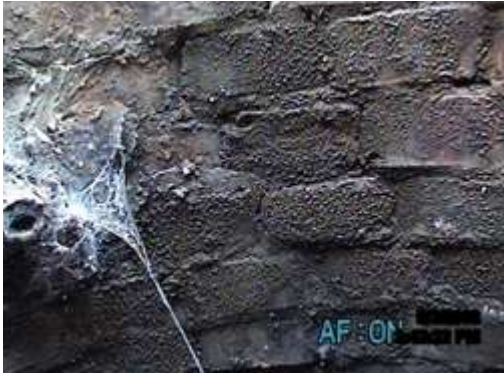
Defect 1

Condition: ☐ Sound ☐ Cracked ☐ Root Intrusion ☐ Loose Brick ☒ **Deteriorated**

deteriorated corbel

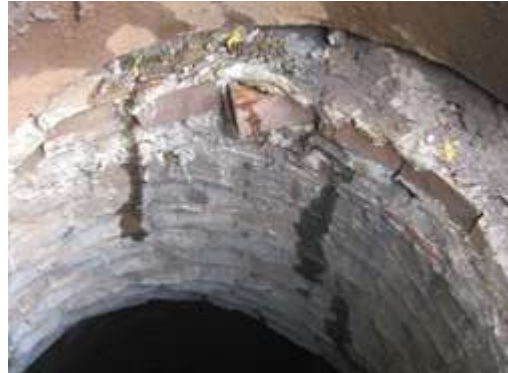
Defect 4

Offset: **3.** (in.)
75

offsett 3.75 inchs

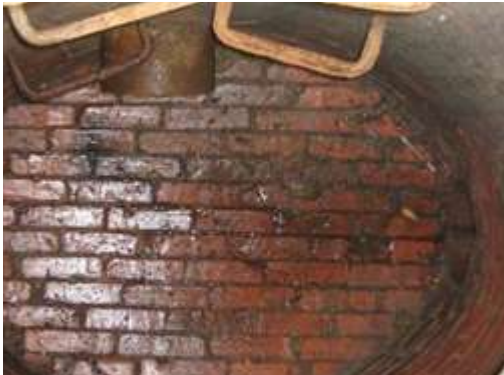
Defect 3

Count: **5** Missing: **0** ☒ **Corroded**

corroded steps

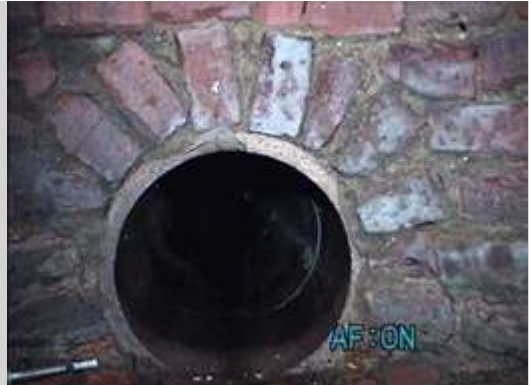
12 O'Clock Outflow

0 in. Circular Gravity Sewer
Pipe Out @ 12 O'Clock

Pipe Height: **10.8** (in.) Rod and Bar (Angled)
Pipe Material: **Clay** ☐ Pipe Lined
Invert Depth: **8.76** (ft.) Flow Characteristics: **None**
Deposits: ☒ None ☐ Mud ☐ Sludge ☐ Debris ☐ Grease
Silt Depth: **0** (in.) Deposits Extent:
Infiltration: **None** Pipe Seal Cond: **Sound**

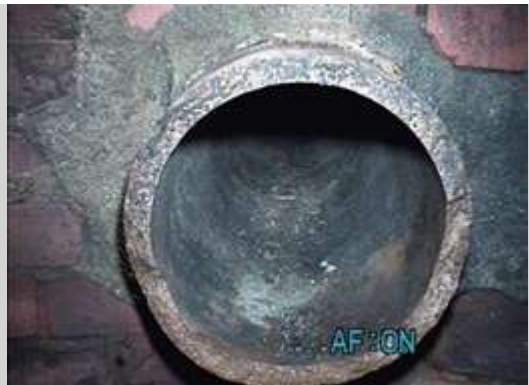
9 O'Clock Inflow

8 in. Circular Gravity Sewer
Pipe In @ 9 O'Clock

Pipe Height: **8.4** (in.) Rod and Bar (Angled)
Pipe Material: **Clay** ☐ Pipe Lined
Invert Depth: **7.60** (ft.) Flow Characteristics: **None**
Deposits: ☒ None ☐ Mud ☐ Sludge ☐ Debris ☐ Grease
Silt Depth: **0** (in.) Deposits Extent:
Infiltration: **None** Pipe Seal Cond: **Sound**
